# **Technical Memorandum Corrosion Assessment of Copper Tubing from Residences in the Cobb County - Marietta Water Authority (CCMWA) Service Area**

**Prepared for:** CCMWA

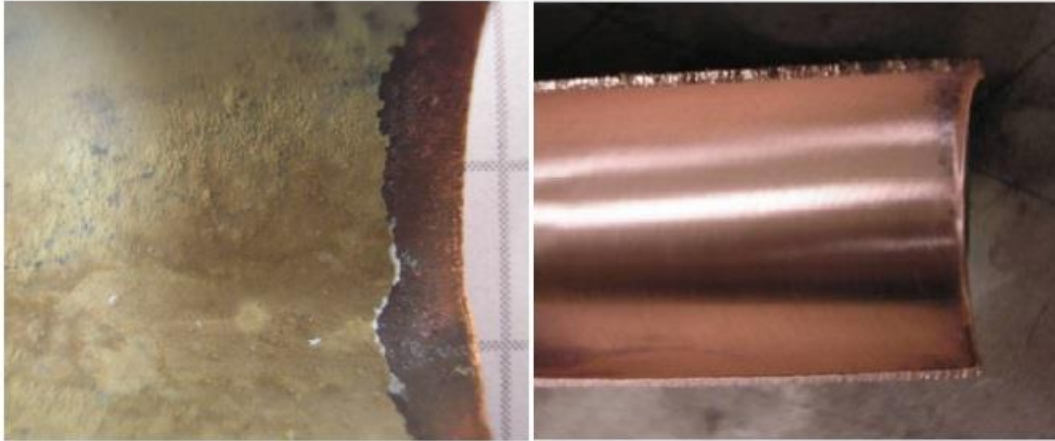
**Figure 2:** Photo on left shows interior of cold water tubing with moderate buildup of cuprite based corrosion scale overlying a more adherent tenorite scale. Photo on right shows the polished underlying surface (pipe floor) with the corrosion scale removed. *Note: this surface is typical of a uniformly corroding copper pipe.*

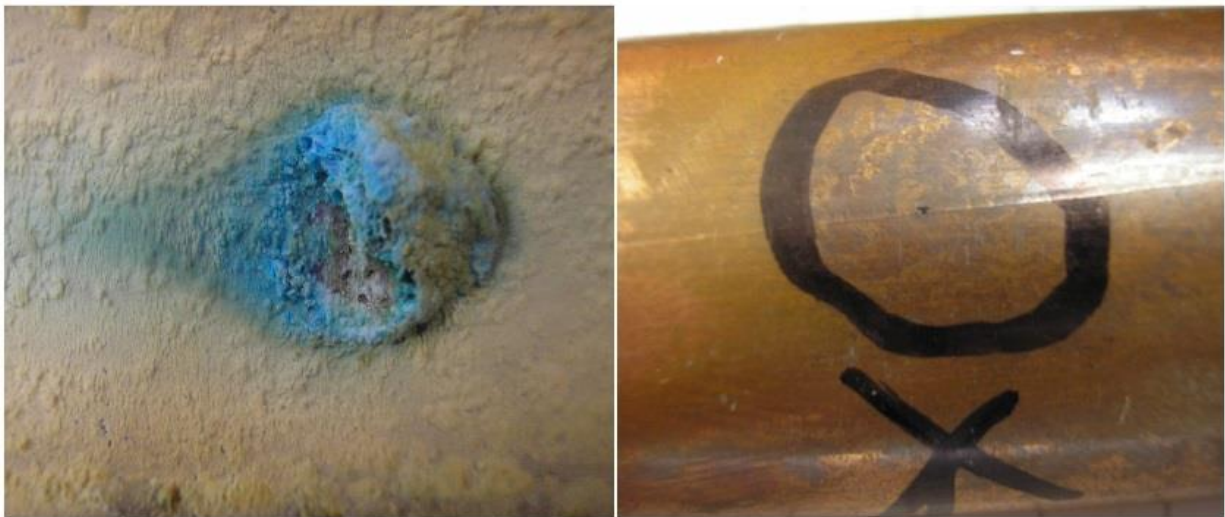
**Figure 3:** (specimen Z) Photo on left shows a typical water-side pitting site with characteristic blue green tuberculation. Photo on right shows the pinhole sized point of penetration on the exterior of the pipe opposite the pit.

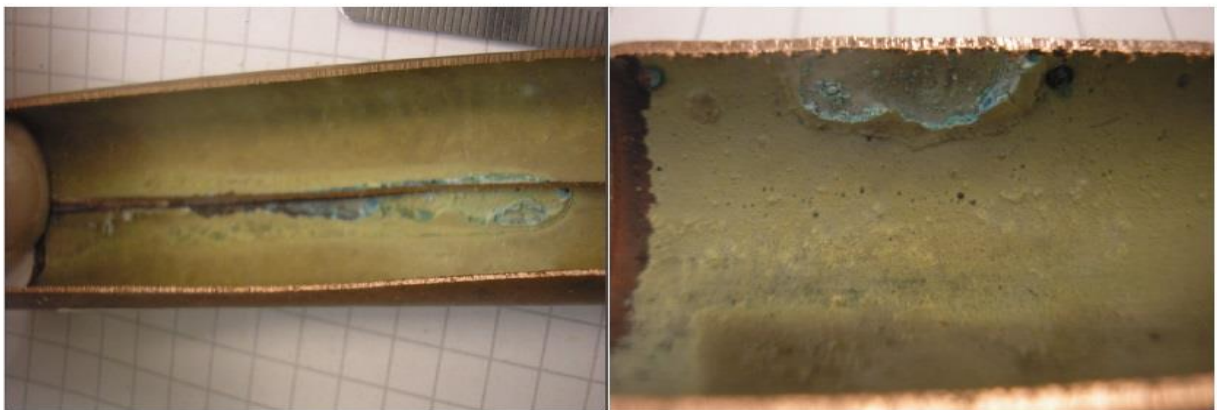
**Figure 4:** (G Specimens) Pipe samples showing strong evidence of flux runs at locations in close proximity to soldered joints. *Note: photo on left shows both halves of sectioned pipe.*

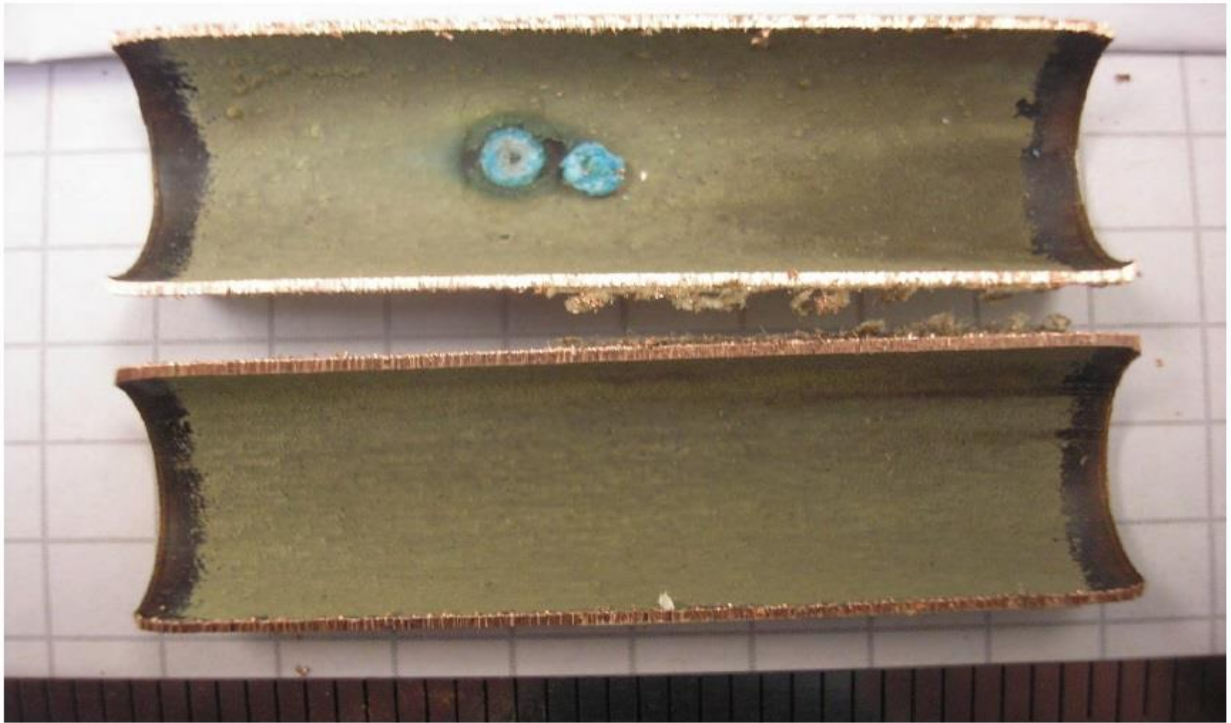
**Figure C5:** Non-perforating pit with tubercle cap removed. *Note: corrosion on the pipe wall of the opposing section is entirely uniform.*

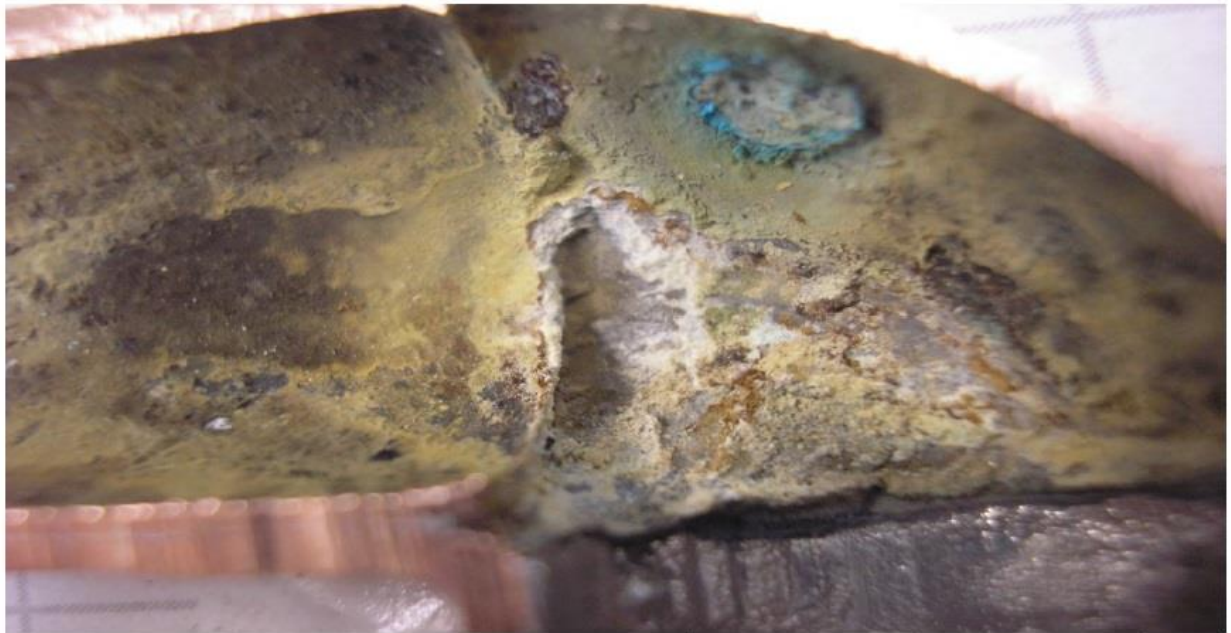
**Figure C6:** Resident G joint sample. *Note: this is a good example of corrosion damage done by excessive solder and flux application.*

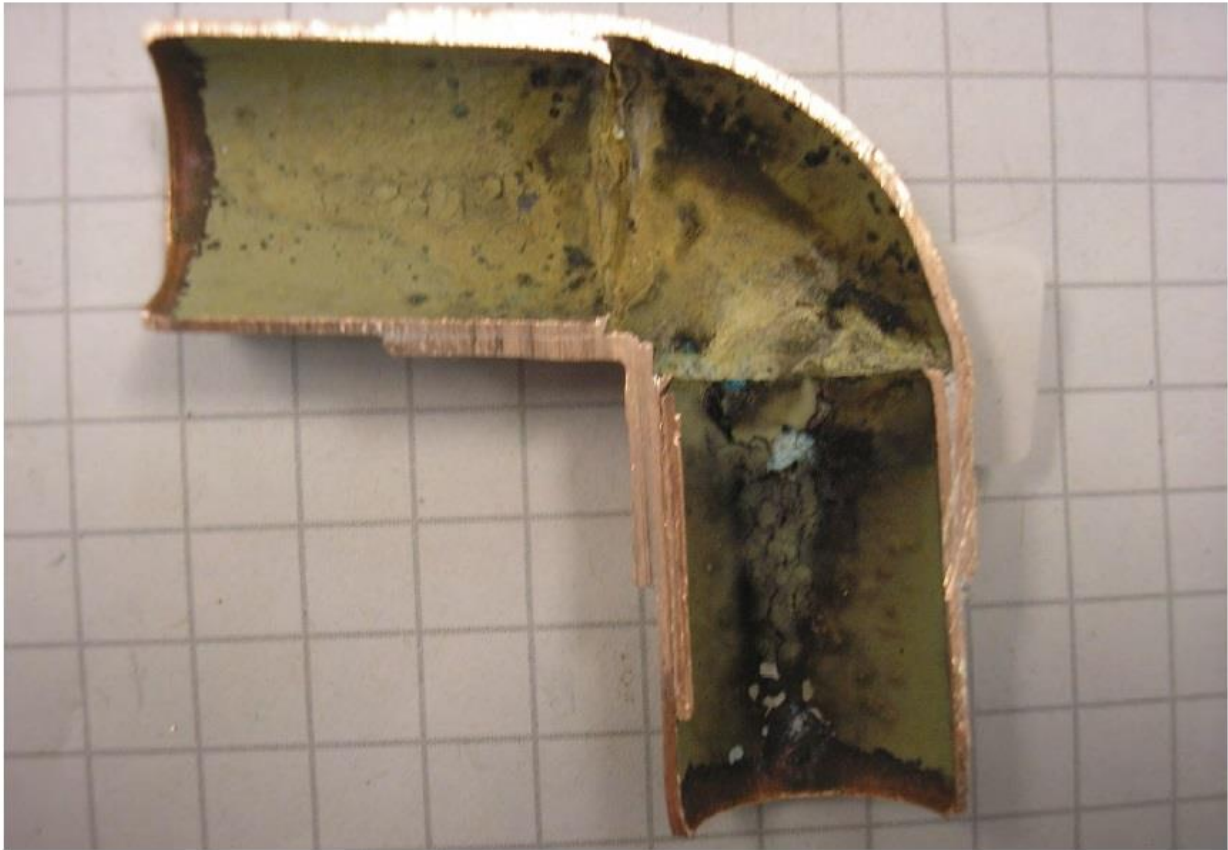
**Figure C7:** Resident G joint sample. *Note: the dark cracked surface appears to be carbonized flux residue.*

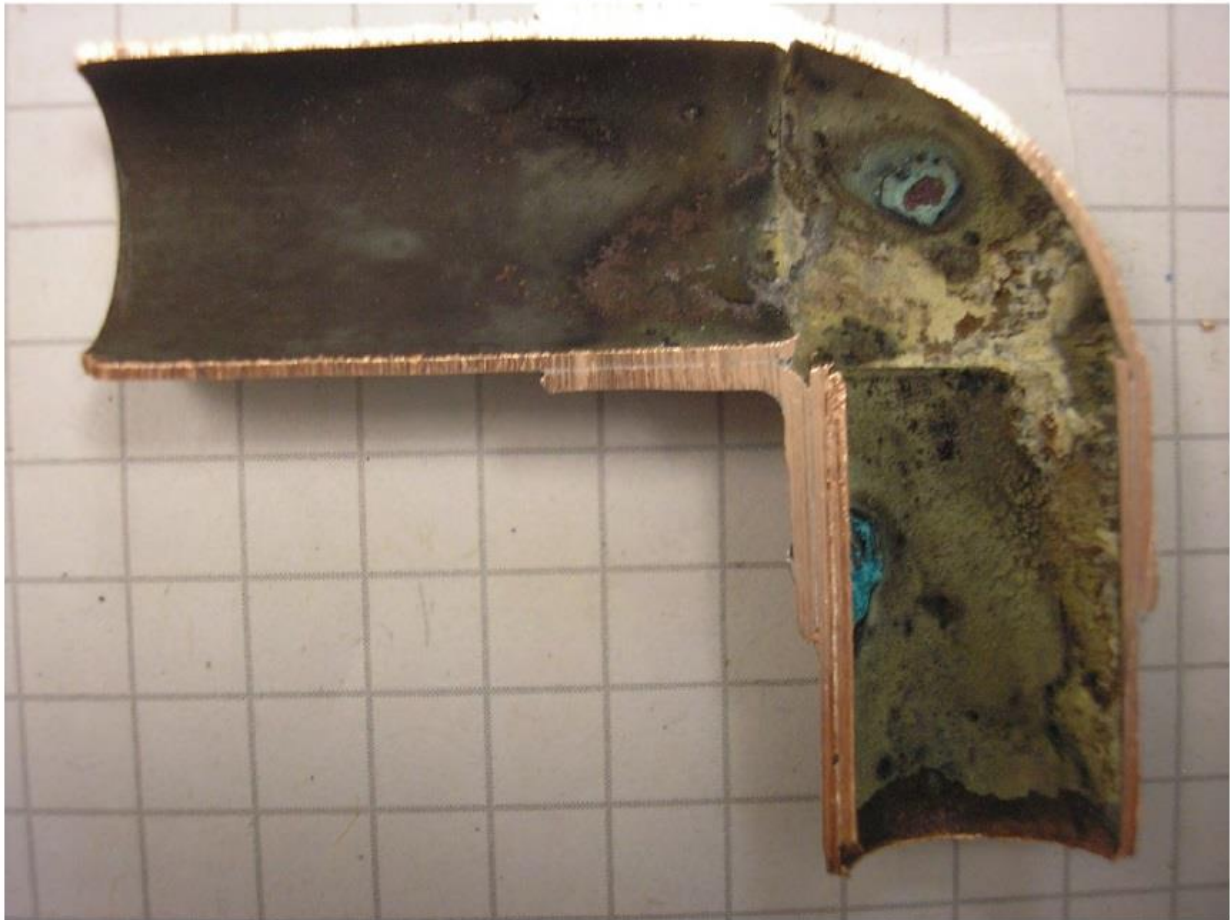
**Figure C8:** Resident G joint sample. *Note: excessive flux application ran down one arm of the joint causing corrosion damage and pitting while the other arm of the joint was largely unaffected. Also note the poorly reamed tubing flairs – this is indicative of poor fabrication quality.*

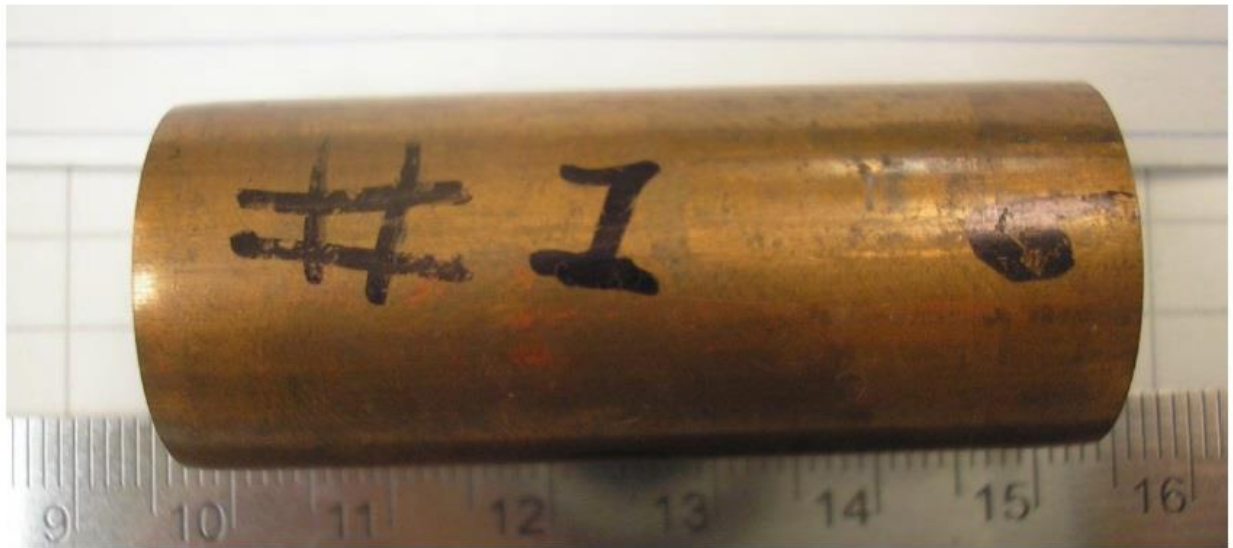
**Figure C9:** Photo of Resident Z household sample (as received).

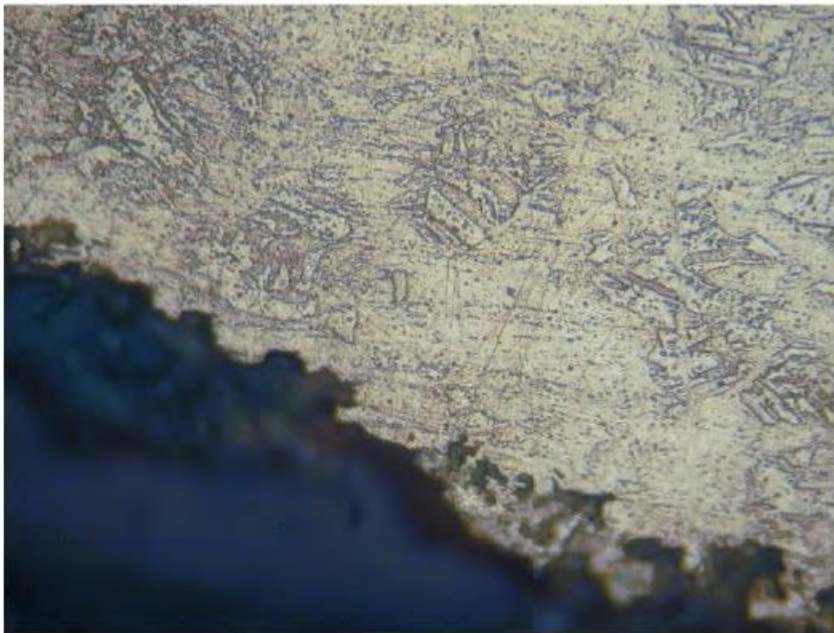
**Figure D4:** Metallographic cross-sectional view (400X) of the pitting site on the Resident Z pipe sample after etching. *Note: the etching has not revealed defects or abnormalities in the copper tubing structure at the pitting sites.*

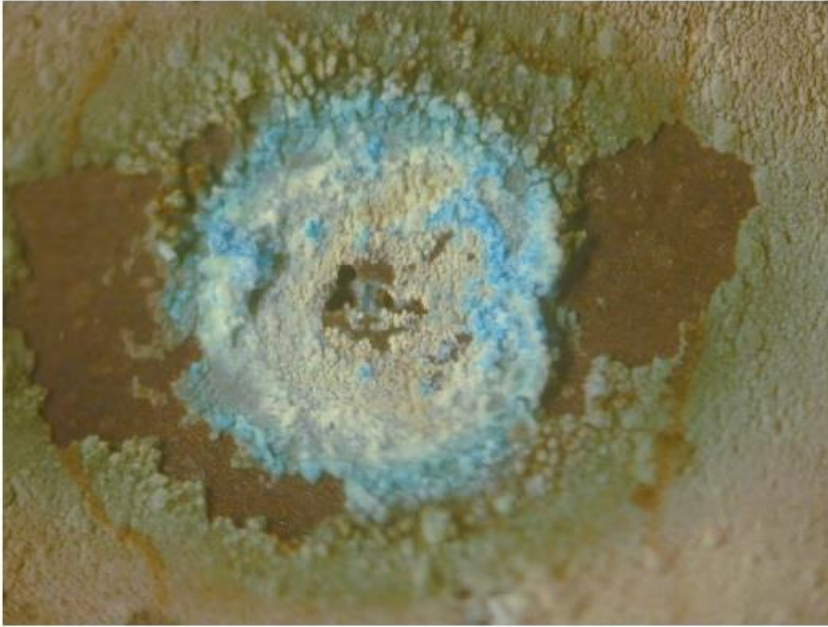
**Figure E1:** Optical image (15X) of an active pitting site on the Resident G tubing.

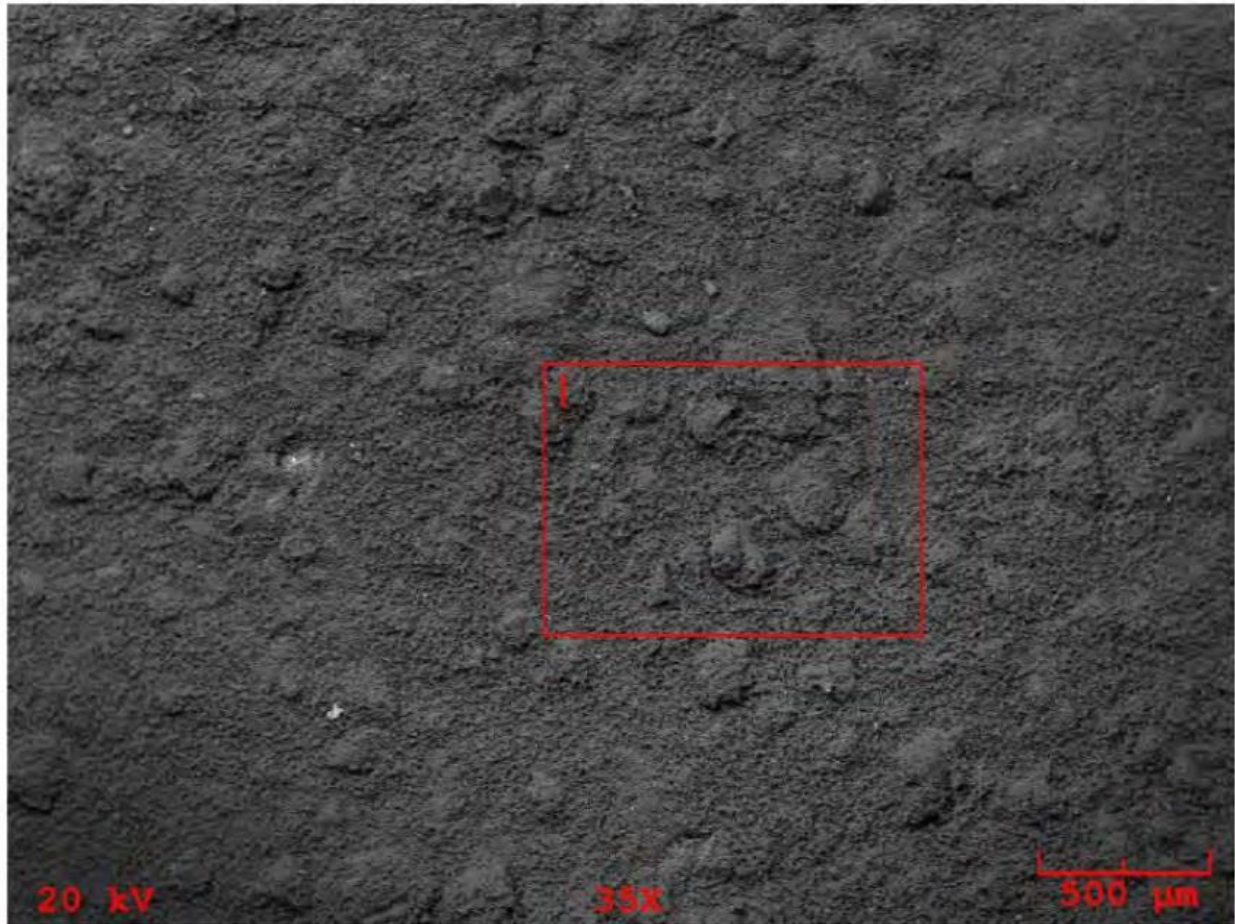
**Figure E7:** SEM image (35X) of the uniform corrosion scale across the bulk of the Resident C sample.

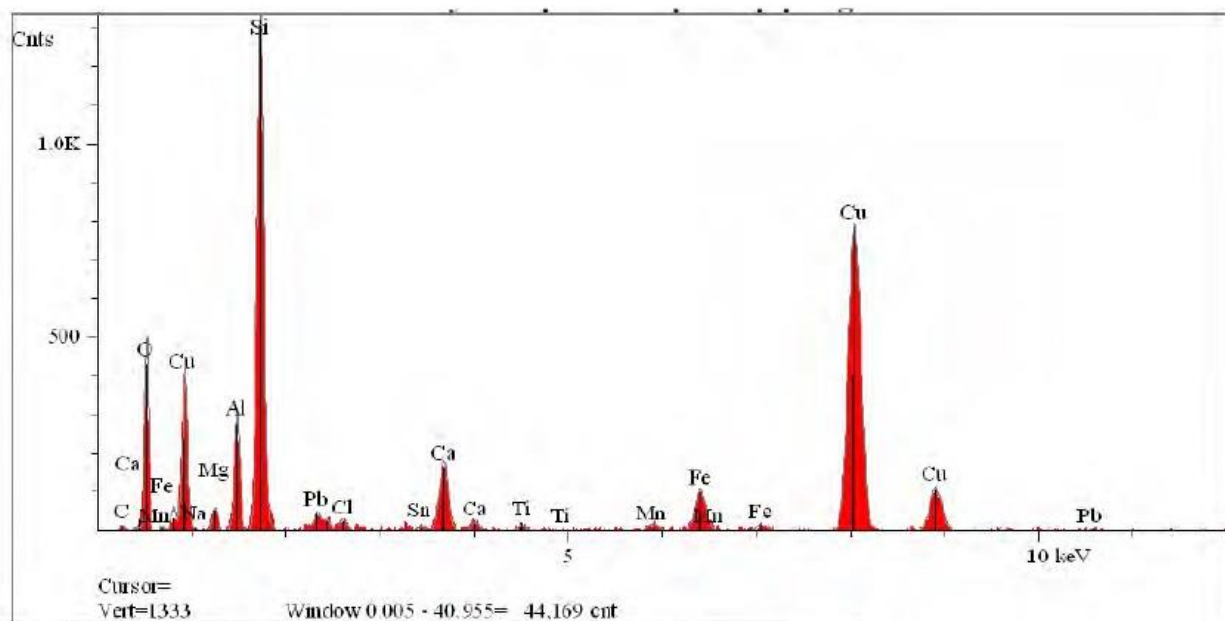
Elt.	Line	Intensity (c/s)	Error 2-sig	Atomic %	Conc	Units	Error 2-sig	
C	Ka	3.14	1.163	4.875	1.507	wt. %	0.558	
O	Ka	87.36	3.478	27.547	11.342	wt. %	0.452	
Na	Ka	1.29	1.209	0.163	0.096	wt. %	0.090	
Mg	Ka	14.35	1.985	1.248	0.781	wt. %	0.108	
Al	Ka	73.80	3.587	4.631	3.216	wt. %	0.156	
Si	Ka	385.38	7.445	20.106	14.532	wt. %	0.281	
Cl	Ka	9.54	2.594	0.367	0.335	wt. %	0.091	
Ca	Ka	64.57	3.804	2.292	2.364	wt. %	0.139	
Ti	Ka	5.25	2.573	0.193	0.238	wt. %	0.117	
Mn	Ka	8.53	2.431	0.354	0.500	wt. %	0.143	
Fe	Ka	51.05	3.395	2.230	3.205	wt. %	0.213	
Cu	Ka	419.93	7.730	35.069	57.351	wt. %	1.056	
Sn	La	4.08	2.540	0.175	0.534	wt. %	0.333	
Pb	La	2.36	1.507	0.750	4.000	wt. %	2.548	
				100.000	100.000	wt. %		Total
