ANALYSIS OF RESIDENTIAL COPPER WATER PIPES

ATS JOB # D280682

METALLURGICAL TEST REPORT

Analysis of Residential Copper Water Pipes

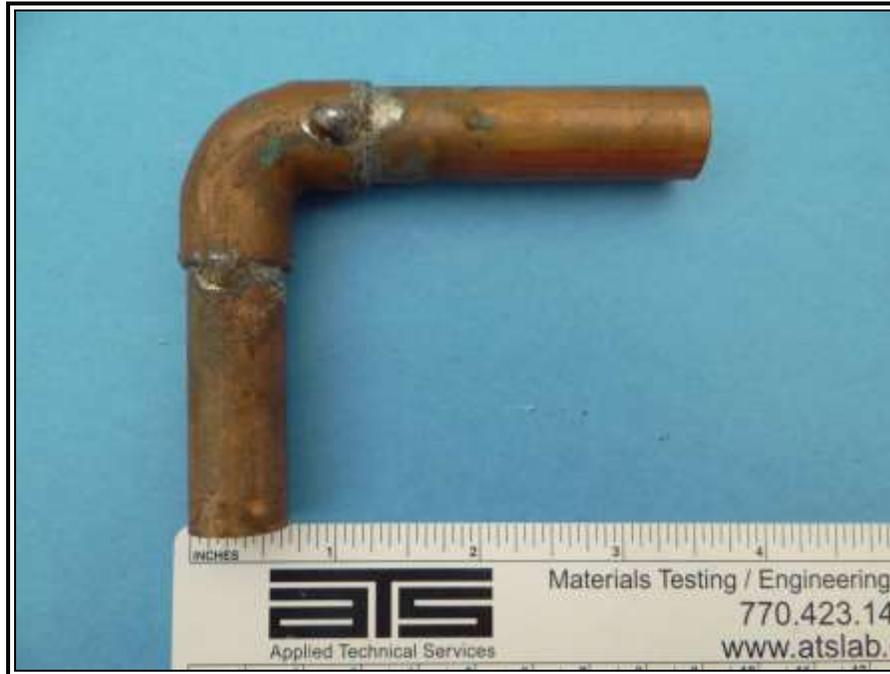
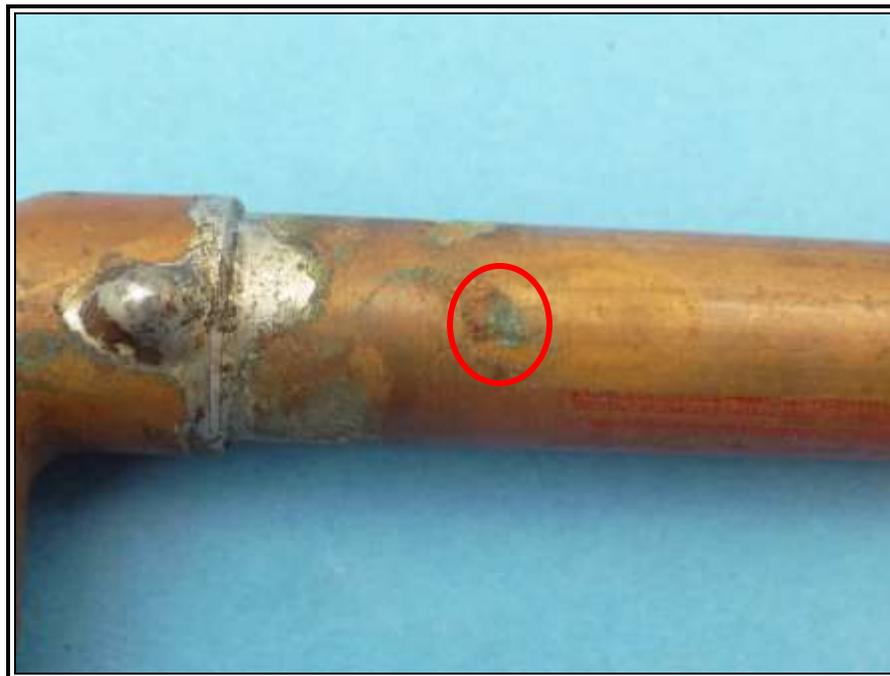
The pipes were documented in the as-received condition (Figures 1 through 4). All of the pipes exhibited similar leak areas at the outer diameter (OD). The rest of the OD surfaces were relatively clean and did not exhibit any corrosion products. The pipes were sectioned open and examined visually. Yellowish deposit was observed along the entire inner diameter (ID) surface of all of the pipes (Figures 5 and 6). Pitting through the pipes were observed initiating from the IDs along with some tubercles.

Figure 1: Photograph of an as-received pipe showing leak location (encircled)

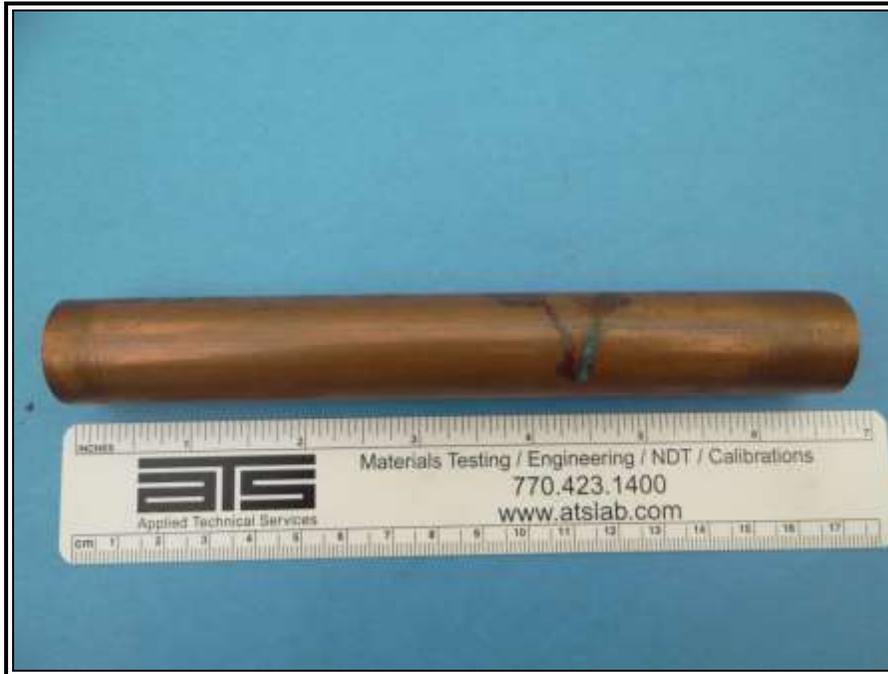
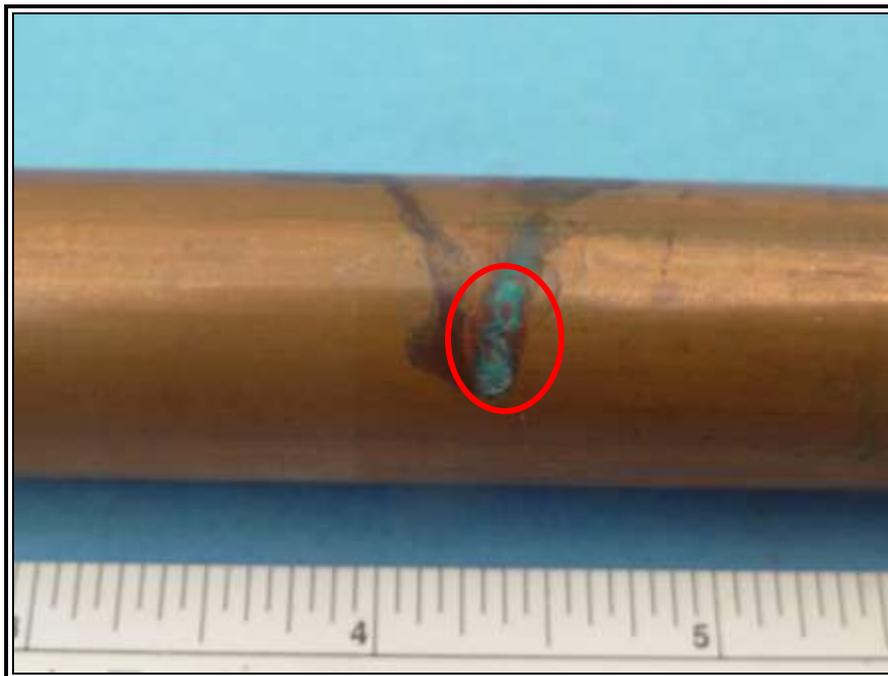
Figure 2: Photograph of an as-received pipe showing leak location (encircled)

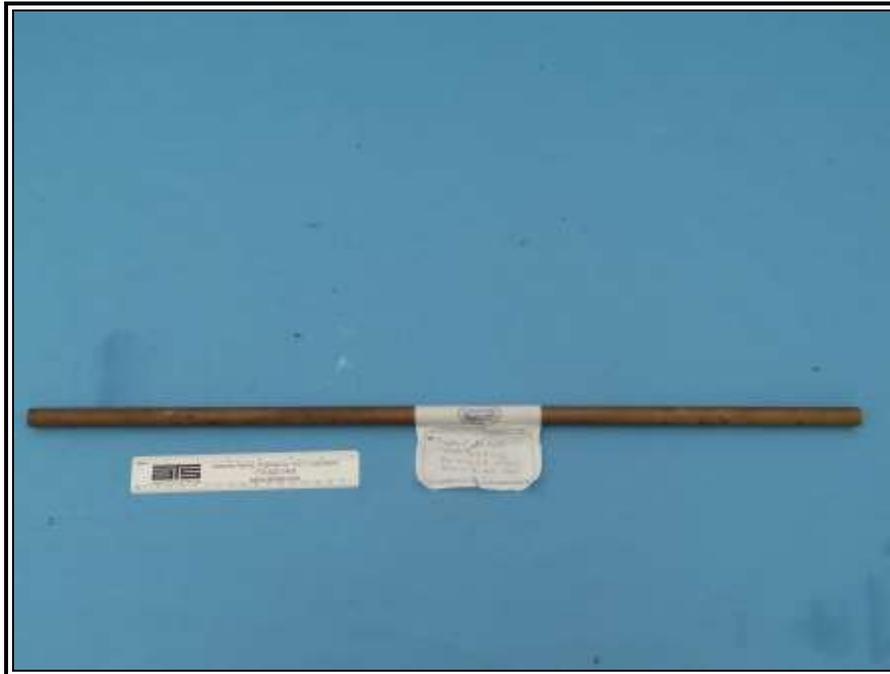
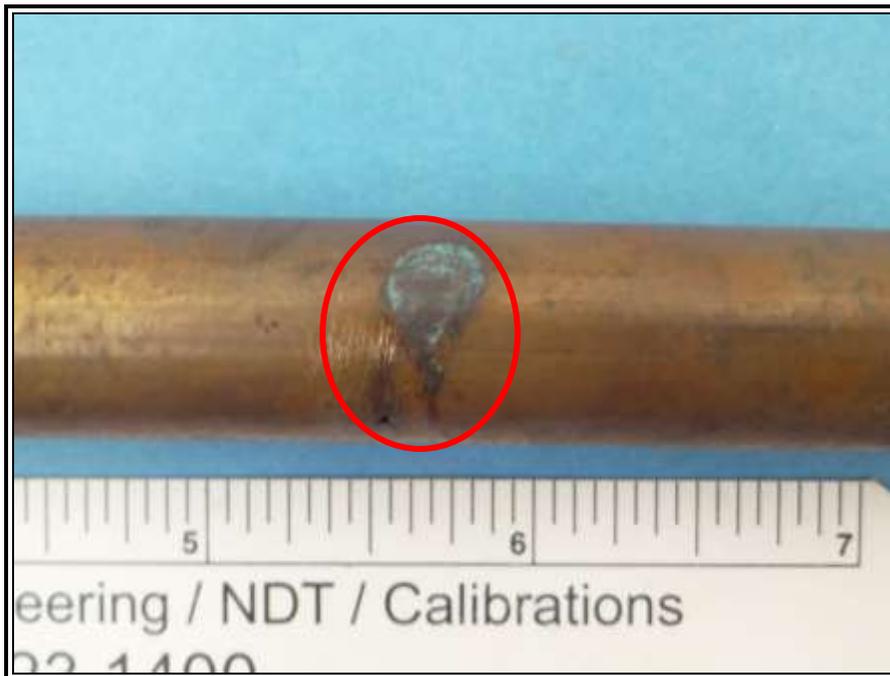
Figure 3: Photograph of an as-received pipe showing leak location (encircled)

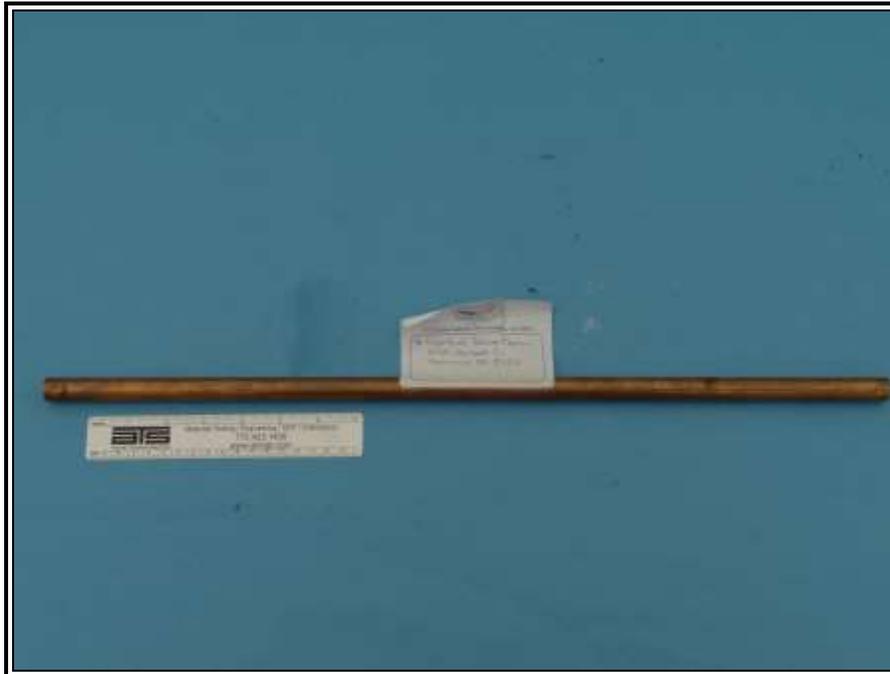
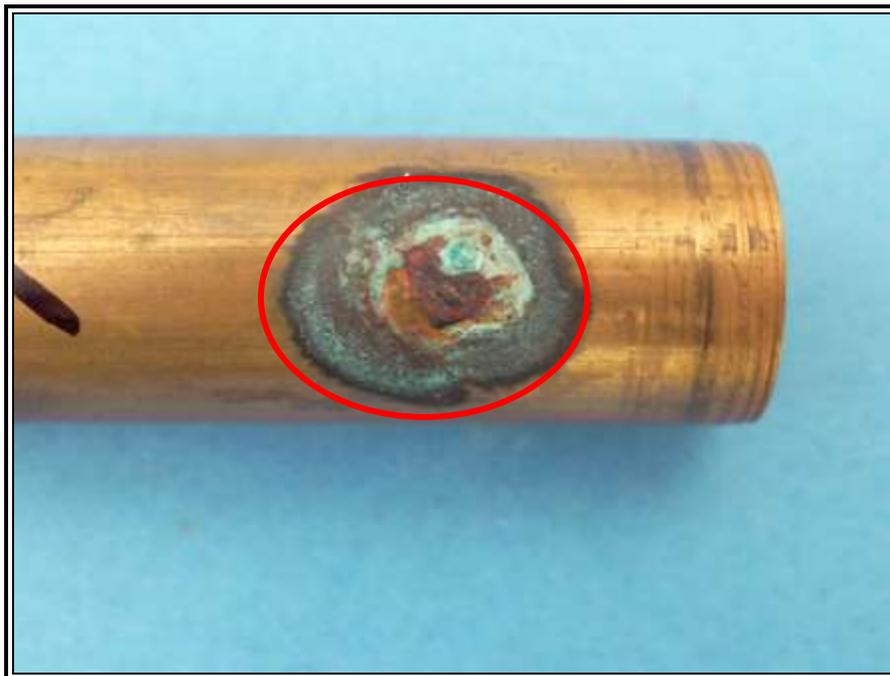
Figure 4: Photograph of an as-received pipe showing leak location (encircled)

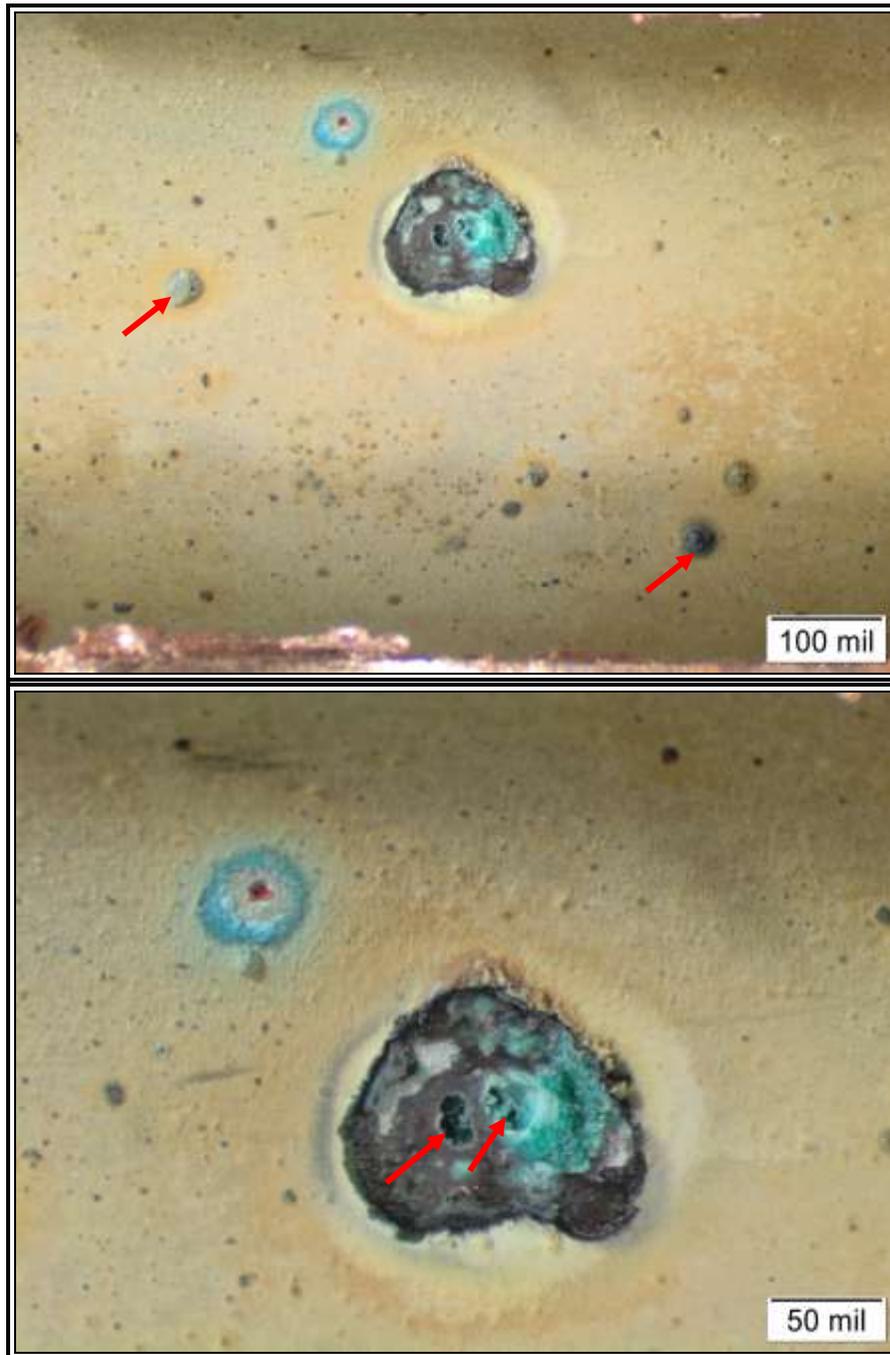
The corrosion mechanism was most likely under-deposit corrosion. Under deposit corrosion occurs when regions on a metal surface have varying degrees of access to oxygen and other ions due to the presence of deposits. Cathodic reactions within the fluid being transported ($O_2 + 2H_2O + 4e^- \rightarrow 4OH^-$) occur at the exposed surfaces, while anodic reactions that dissolve the base metal ($4Cu + 2H_2O \rightarrow 2Cu_2O + 4H^+ + 4e^-$) occur beneath deposits. The excess H^+ ions beneath the deposit also attract chlorine and sulfur ions if present in the fluid that can create acidic conditions under the deposit and further accelerate corrosion. Corrosion can occur even when large distances separate the exposed and “under-deposit” surfaces, provided they are in electrical contact.

Figure 5: Photomicrographs showing the ID of a pipe exhibiting tubercles (top, arrows) and the pitting (bottom, arrows)

Note the yellowish deposit at the ID surfaces.

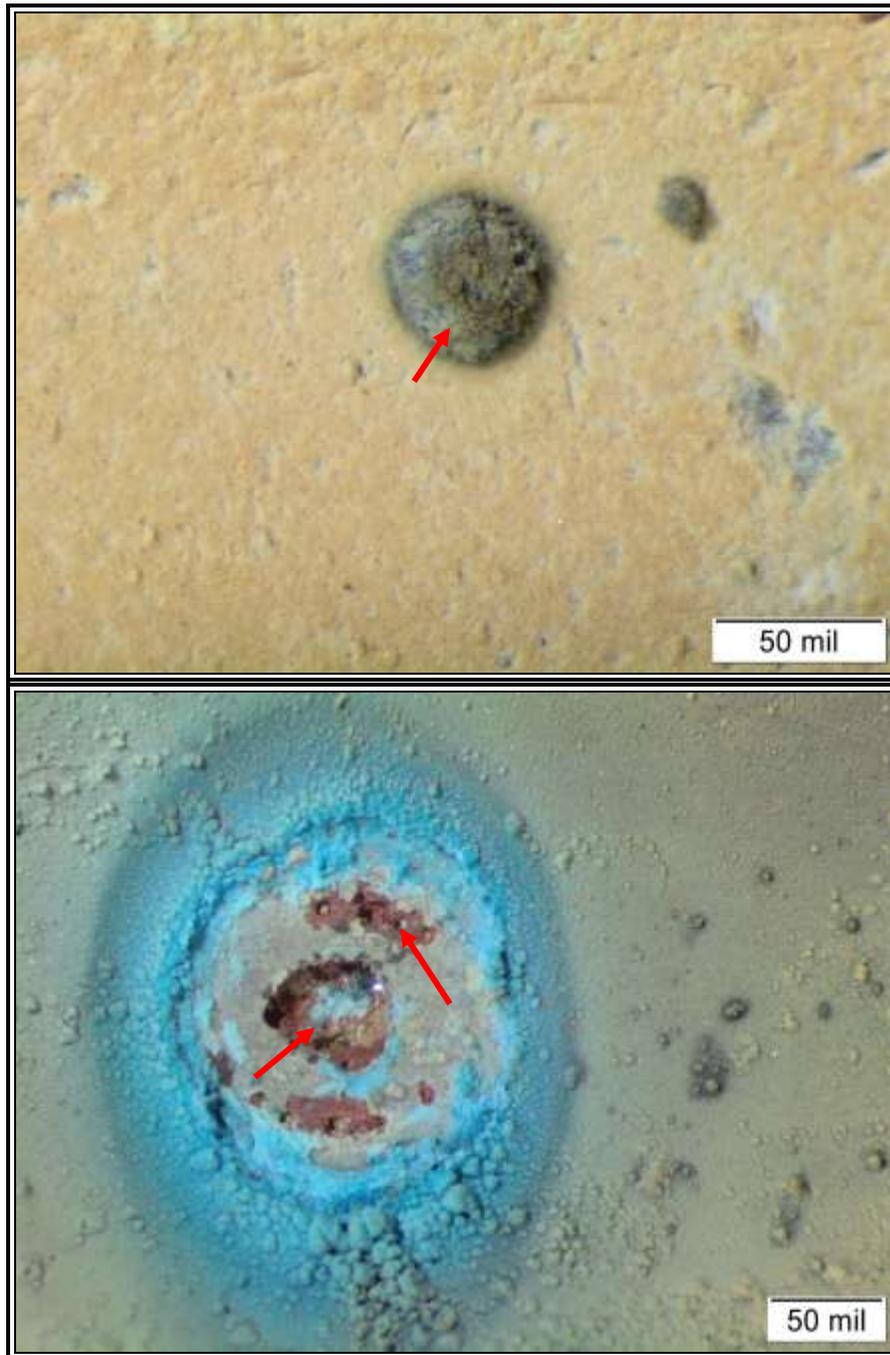
Figure 6: Photomicrographs showing the ID of a pipe exhibiting a tubercle (top, arrows) and the pitting (bottom, arrows)

Note the yellowish deposit at the ID surfaces.

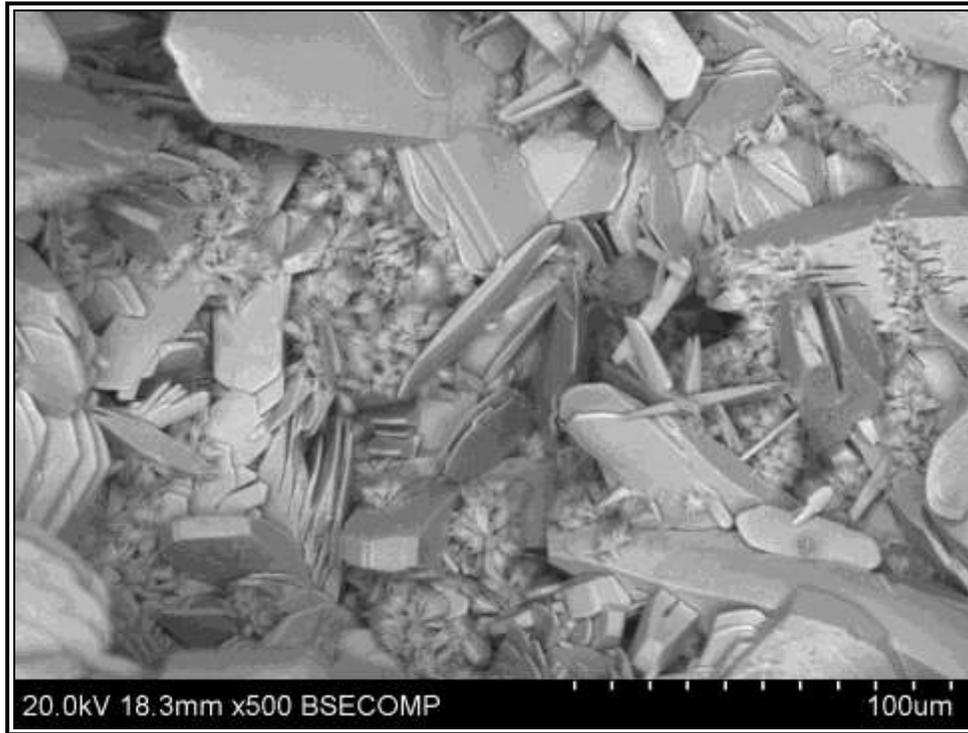
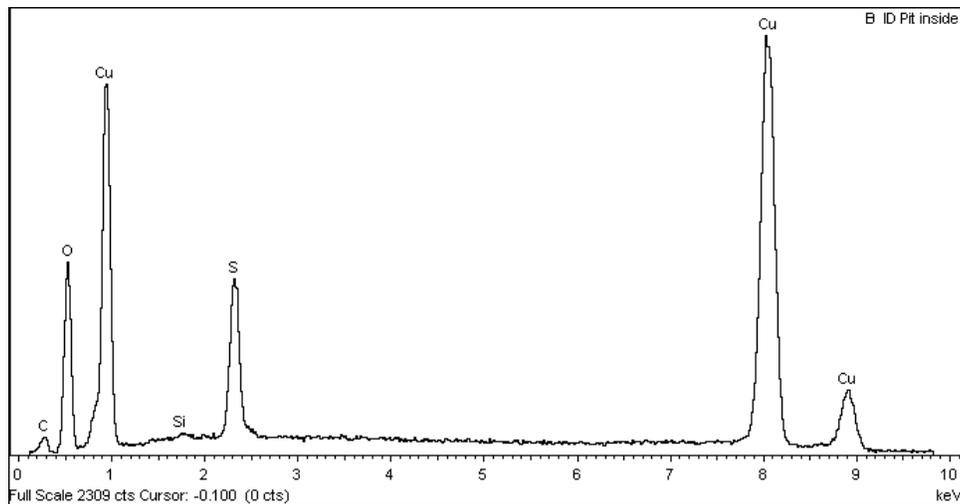
The ID deposits and pitting areas were chemically analyzed per ASTM E1508-12, *Standard Guide for Quantitative Analysis by Energy-Dispersive Spectroscopy*. The corrosion products within the pits consisted of copper oxide with significant concentrations of sulfur and silicon. The yellowish ID deposits exhibited elevated concentrations of silicon and aluminum. See Figures 7 and 8 for the EDS spectra and the SEM images.

Figure 7: Back-scattered electron image (top) and EDS spectrum (bottom) of a corrosion pit (bottom)

Carbon (C), oxygen (O), copper (Cu), silicon (Si), and sulfur (S) were detected

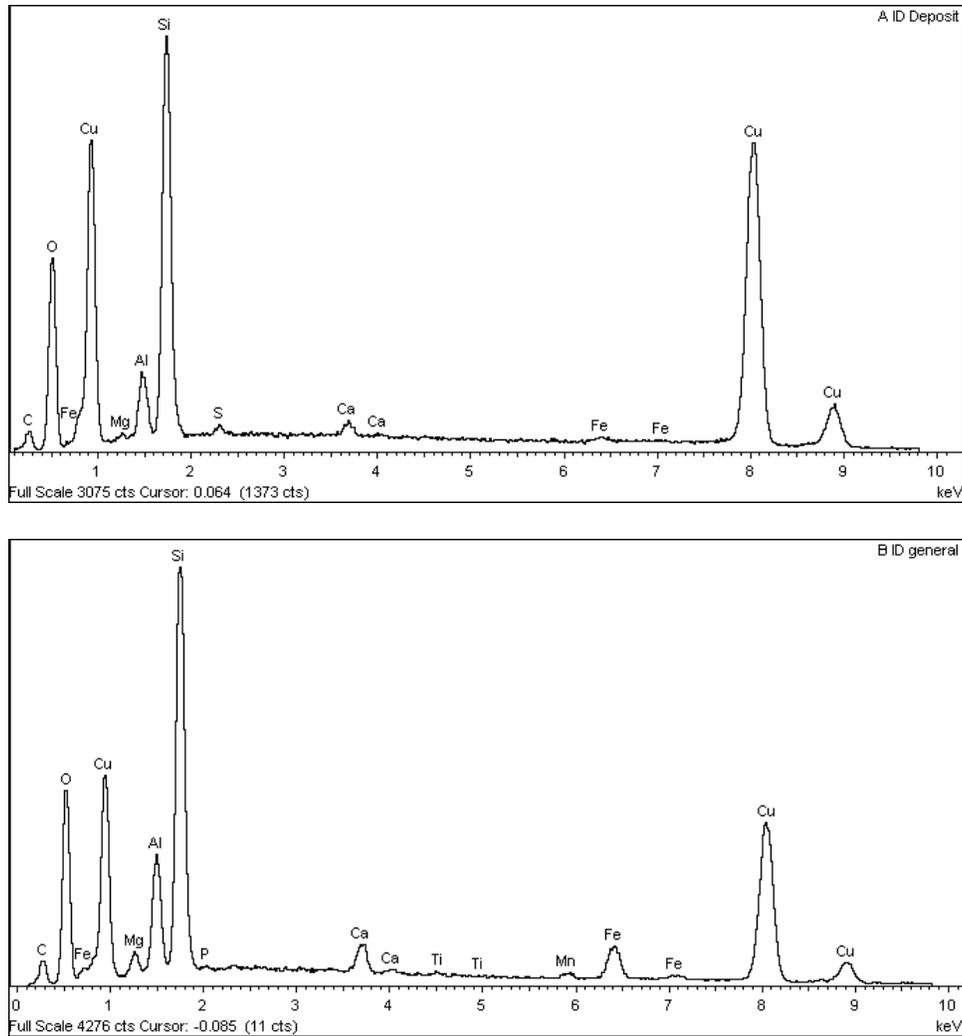
The ID deposits exhibited significant concentrations of silicon and aluminum. The customer reported that no silicate based corrosion inhibitors were used in the system. Silica/sand is another possibility and usually seen in well waters or may be coming from a deteriorating concrete water main. The cause of this silicon rich deposit should be investigated.

Figure 8: EDS spectra of the ID deposits from different pipes

Carbon (C), oxygen (O), iron (Fe), copper (Cu), magnesium (Mg), aluminum (Al), silicon (Si), phosphorus (P), sulfur (S), calcium (Ca), titanium (Ti), and manganese (Mn) were detected.

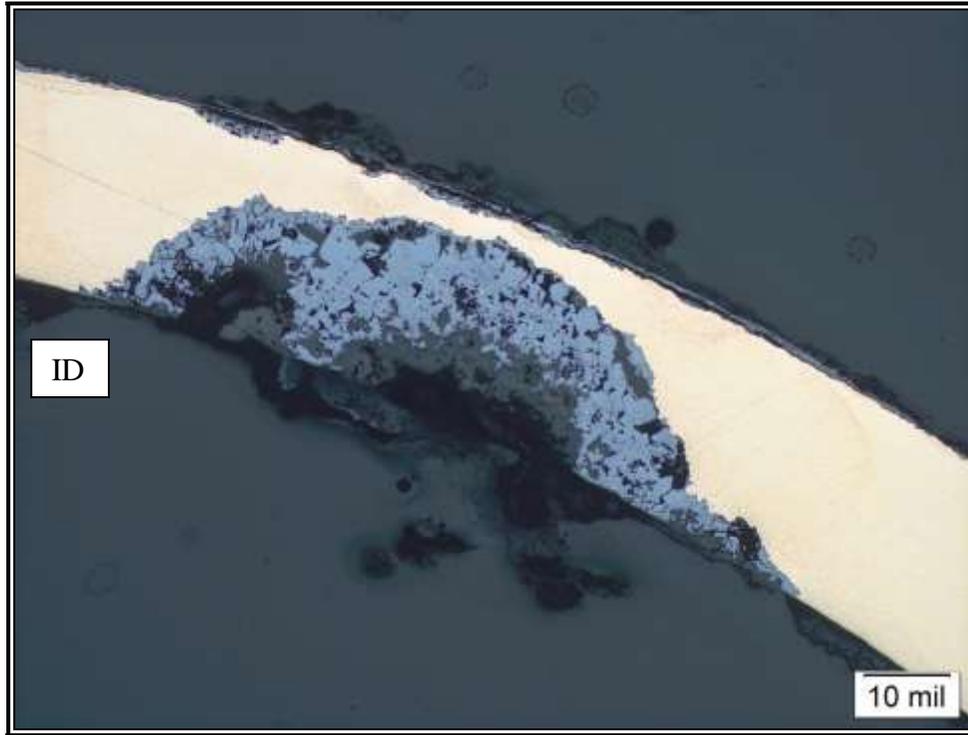
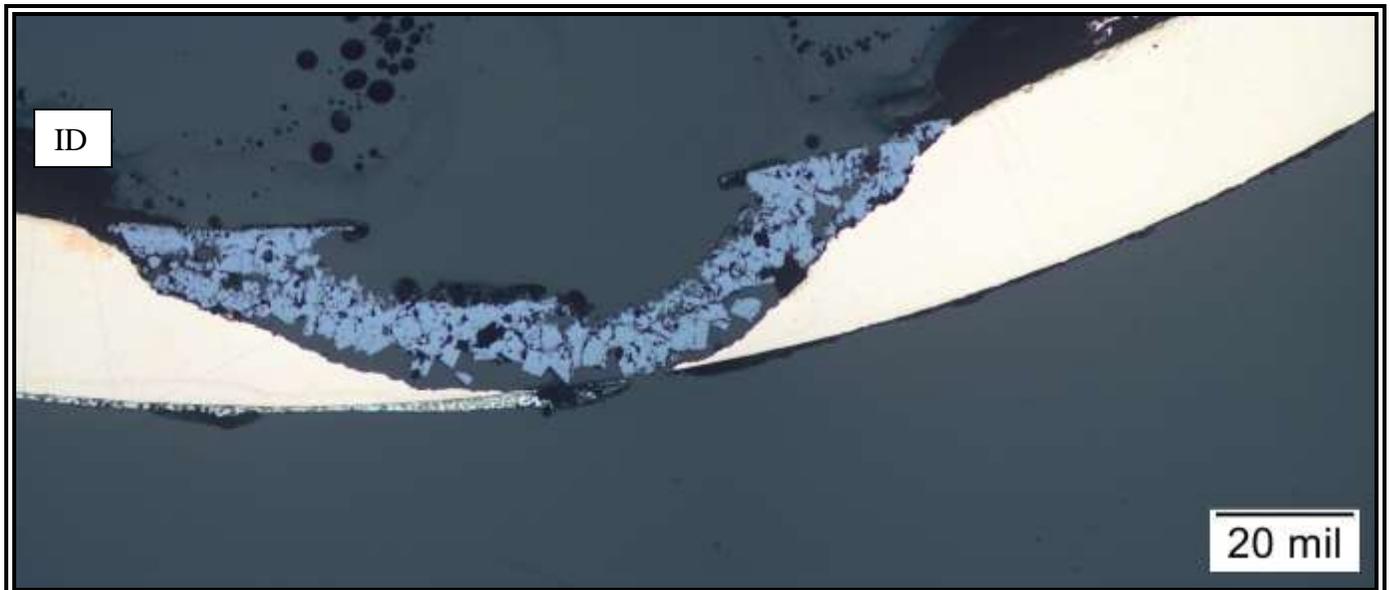
The pipes exhibited localized pitting initiating on the ID surface that corroded through the pipe wall to form pin hole leaks. Pitting corrosion is the non-uniform localized attack of the copper pipe wall which initiated on the interior/waterside surface in the domestic water distribution system.

Figure 9: Photomicrographs of the samples exhibiting localized pitting corrosion of the ID and propagating through to the OD

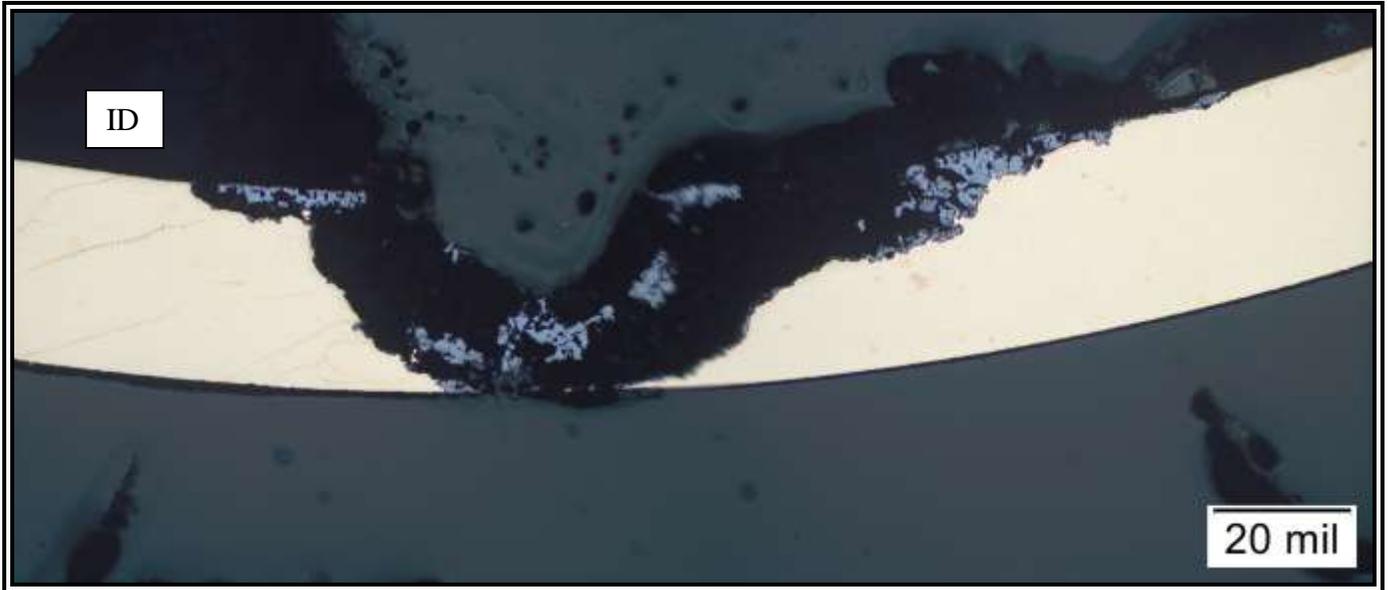
Figure 10: Photomicrograph of a pipe sample exhibiting localized pitting corrosion of the ID and propagating through to the OD

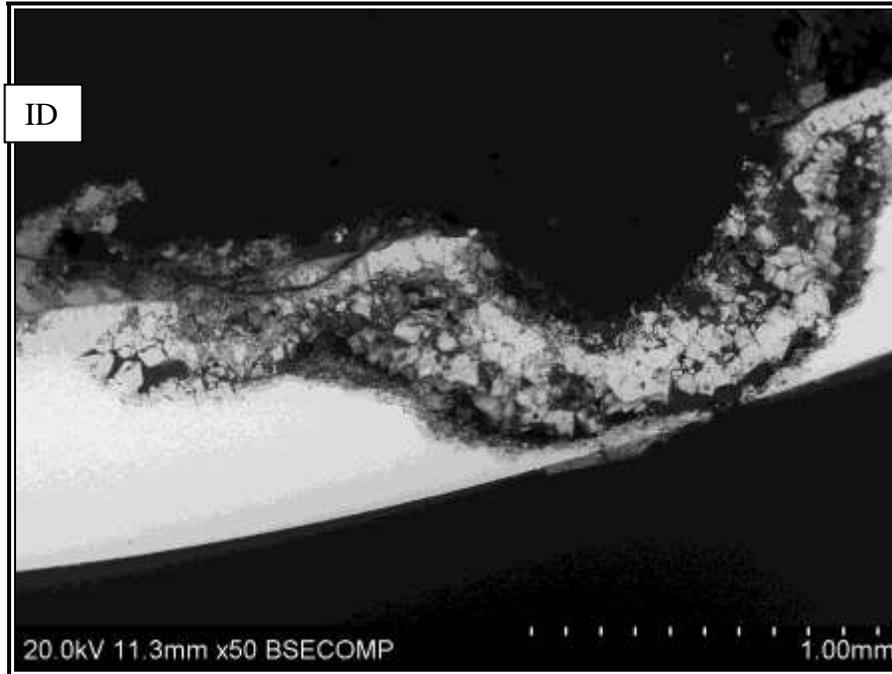
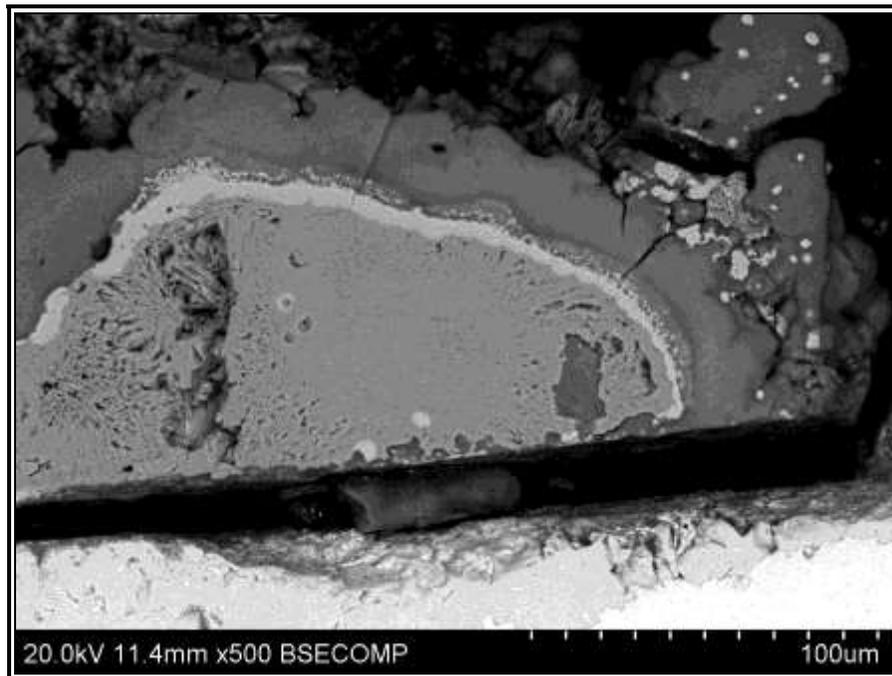
Figure 11: Back-scattered electron image of a pipe sample exhibiting localized pitting corrosion (top), and the OD deposit (bottom)

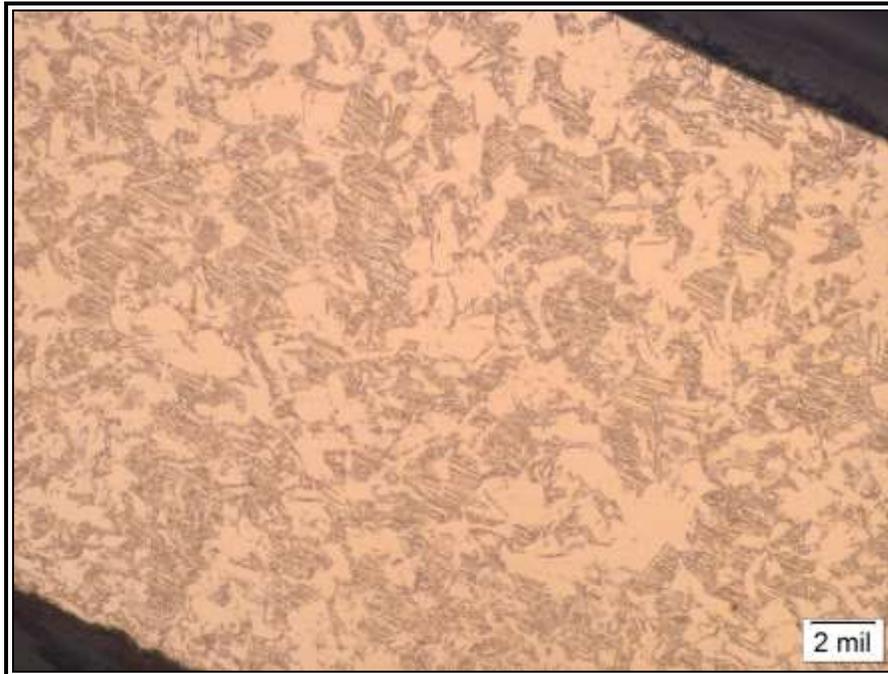
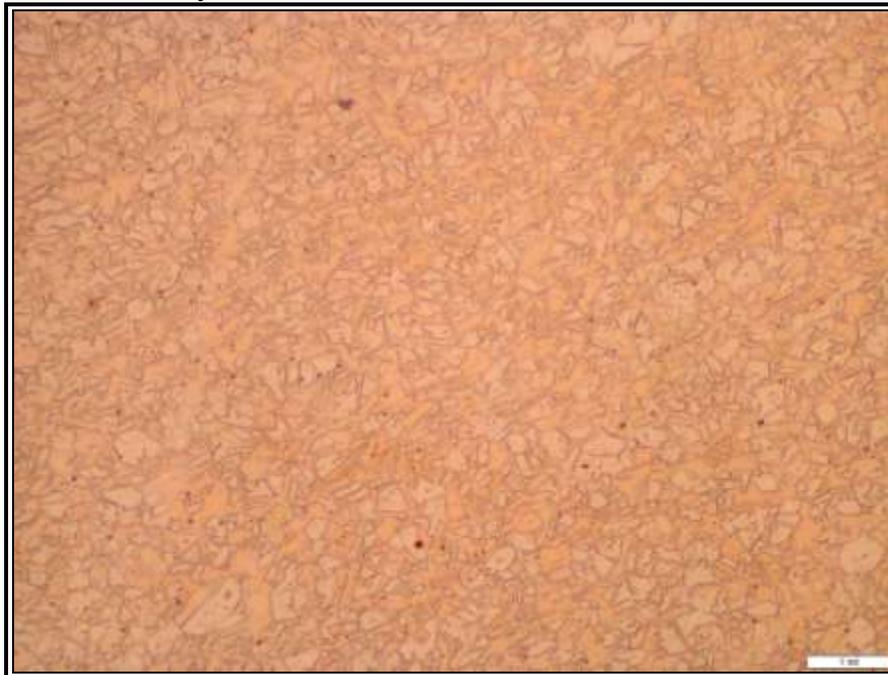
No pipe material abnormalities that could contribute to the corrosion was observed.

Figure 12: Photomicrographs of the pipe sections showing the typical microstructure
